# Inspection Report

**Rich & Kathy Jordan**  
**11601 Pebblepointe Pass**  
**Pineville, LA 71360**

# DEFICIENCY REPORT

Cenla Home Inspection Services, 176 Adams Path Pineville, La 71360, Ph: (387)447-3106

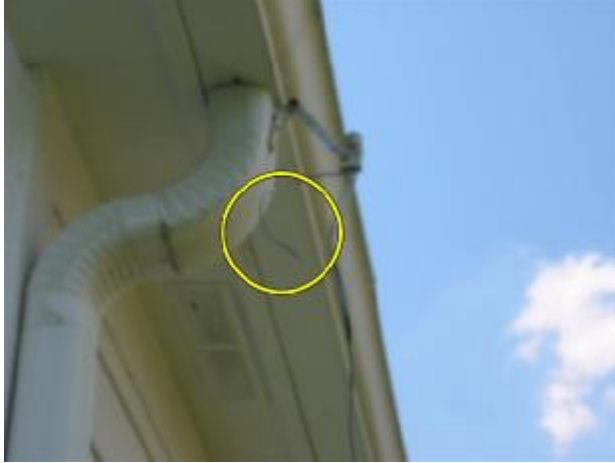
**Roof # R1**

19 Rain gauge wiring is hanging from gauge. Wiring should be fastened to downspout to prevent it from being torn loose (see photo 1).

**Wiring should be fastened to downspout to prevent it from being torn loose**

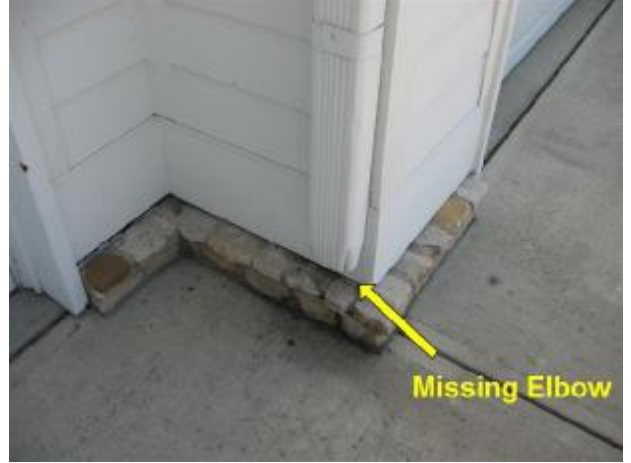
**Roof # R2**

Elbow missing from the north side of double vehicle door (see photo 2)

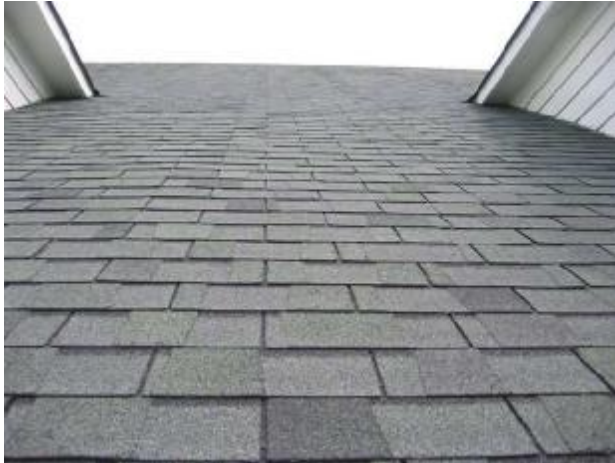
**Roof # R3**

Inadequate ventilation in attic resulting in premature aging of shingles along the west (front) slope around the dormers. Recommend an improvement in ventilation and replacement of roof shingles. (see photos 3 and Attic 1).

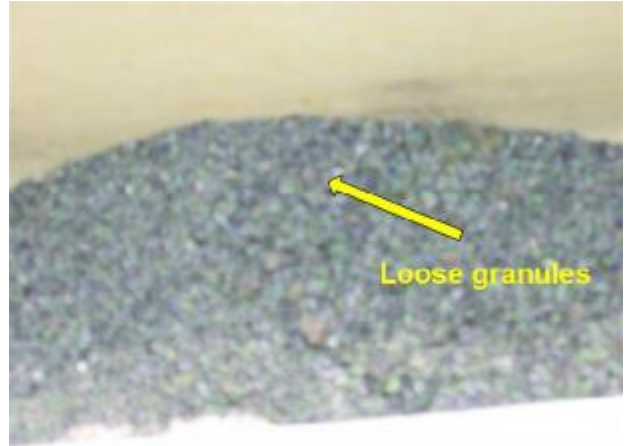
**Roof # R4**

There is a very heavy collection of roofing aggregate in the gutters. Excessive heat can cause aggregate loss and reduced shingle life (see photo 4).

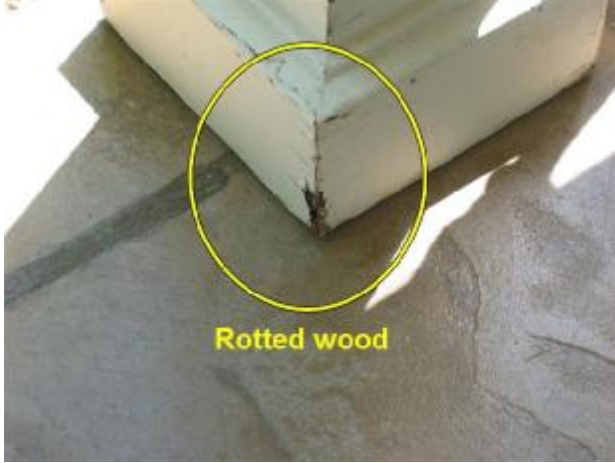
**# EX1**

16 The wooden support posts for the porches on rear verandah rest on the concrete floor. The posts should rest on plates or be otherwise raised to avoid long term moisture contact (see photo 1). Recommend replacement of trim at base of all columns.

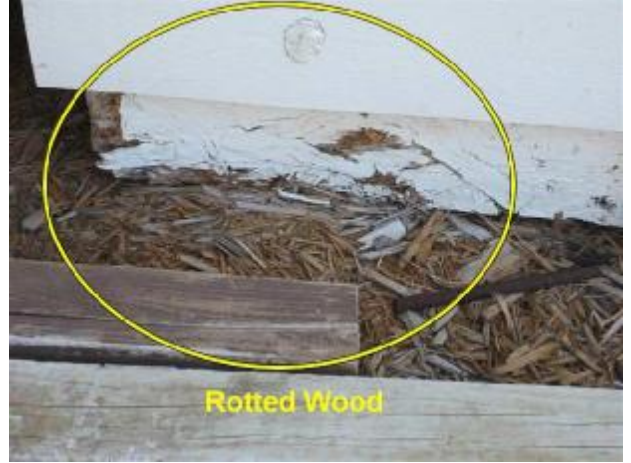
**# EX2**

Replace or remove concrete forms at NW foundation of garage (see photo 2).

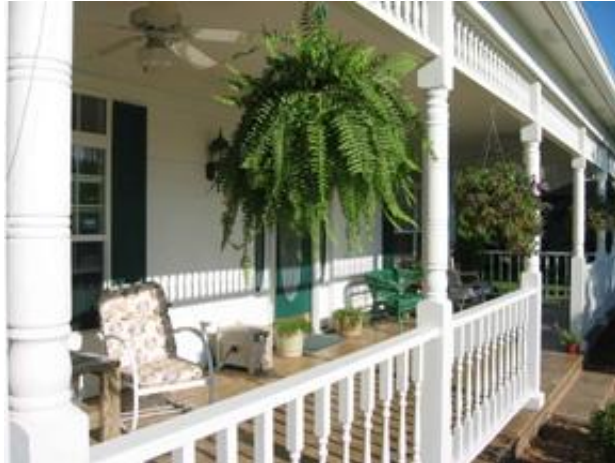
**# EX3**

The exterior paint on trim is deteriorating and should be repainted. The railing system on the front and back porch contains numerous rotted boards which need to be replaced (see photo 3).

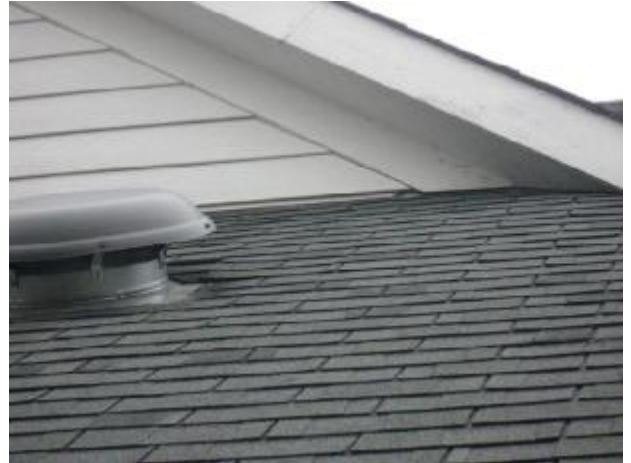
**# EX4**

Some siding panels are slightly warped and in close approximation to roofing. Ice dams can cause some damage to this siding under certain conditions (see photo 4). Recommend caulking to prevent water entry.

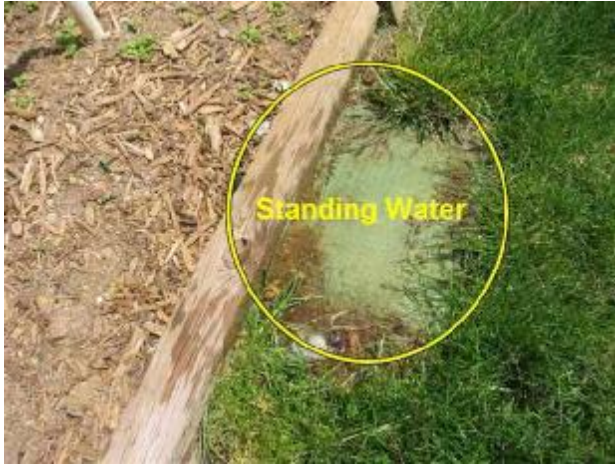
**Grounds & Drainage # GD1**

17 Sprinkler pit on south side of house is flooded. Unable to test system. Recommend evaluation by sprinkler system professional (see photo 1).

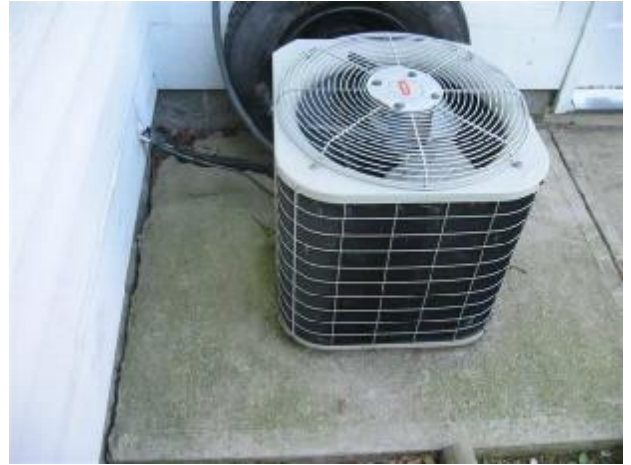
**Grounds & Drainage # GD2**

AC condenser slab slopes approximately 2" towards foundation. Recommend that slab be leveled to prevent water from flowing under slab (see photo 2).

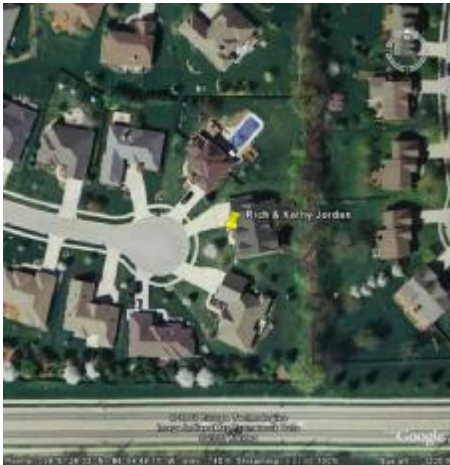
**Grounds & Drainage # GD3**

Aerial view of property. Note tree line which contains swail that shows signs of standing water. (see photo 3).

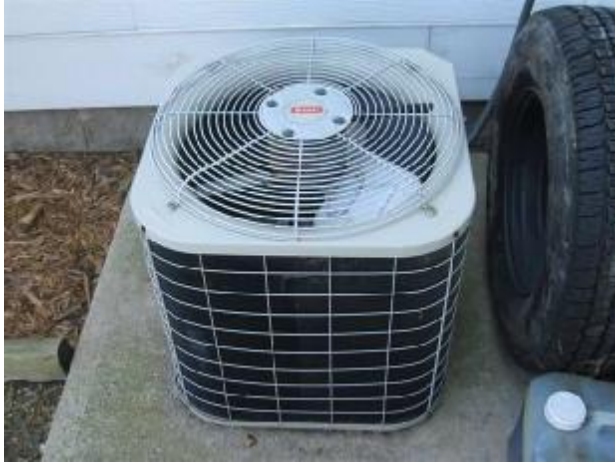
# HC1

24 There is some accumulation of dirt and debris on the condenser coils. Cleaning is recommended (see photo 1).

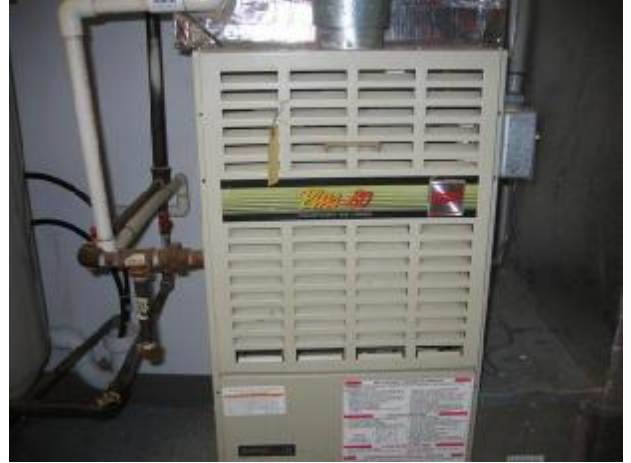
# HC2

The air conditioning unit is 36,000 BTUs. The living area of the home is shown as exceeding 3,300 square feet. The system should be evaluated by a qualified air conditioning technician for adequacy (see photo 2).

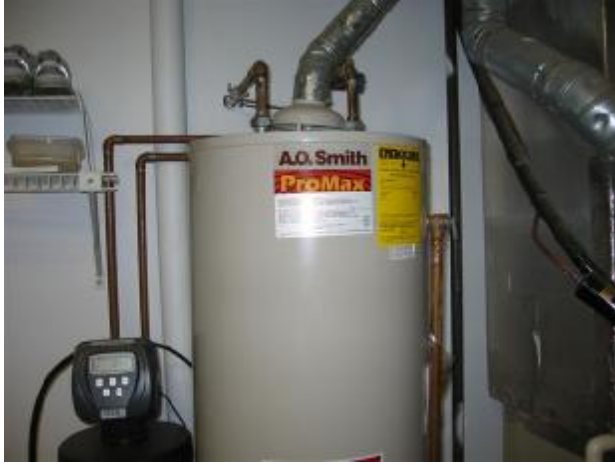
# P1

20 New A.O.Smith hot water heater per homeowner in 2005 (see photo 1).

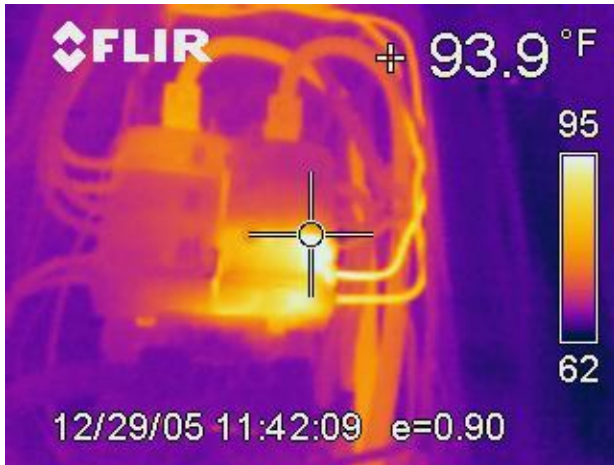
# EL2

19 Hot spot observed in main panel (see photo 2). Recommend evaluation by licensed electrical contractor.

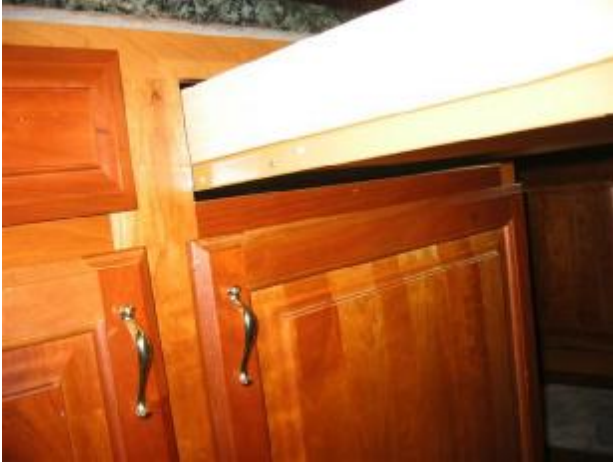
**# K1**

26 Track on island drawer defective (see photo 1).

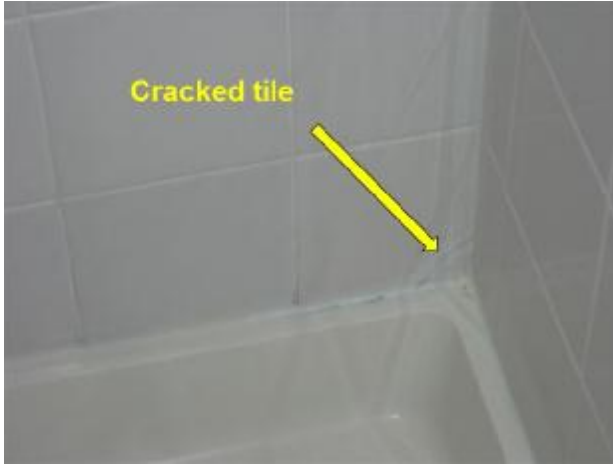
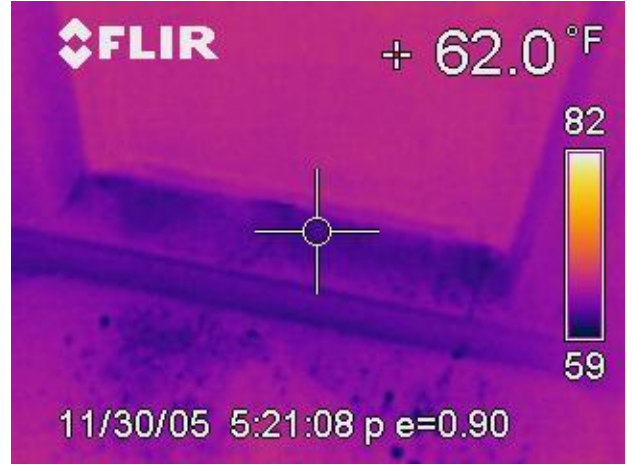
14 Cracked tile in Master Bath shower has allowed moisture to penetrate the wall and floor around shower pan (see photos 1 & 2).

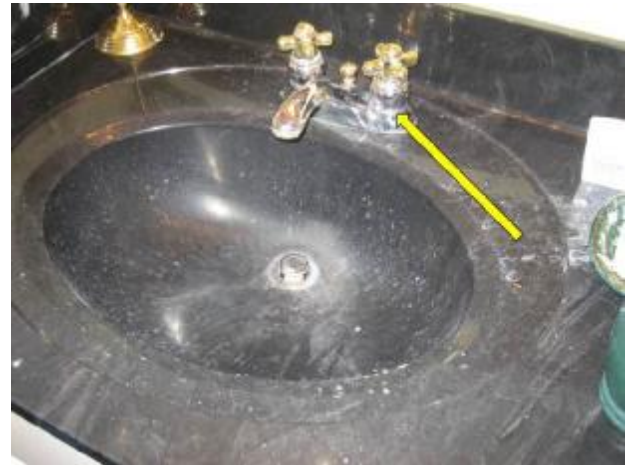
**# B4**

Leaky cold water faucet in left sink of guest bath. Replace washer. (see photo 4).

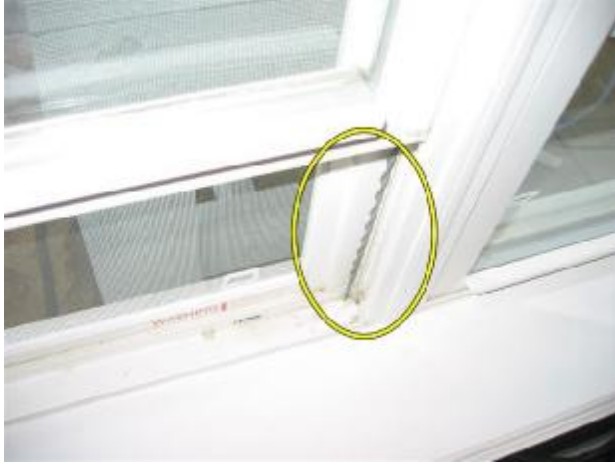
**# IR1**

17 Double hung window at SE corner of living room is inoperative. (see photo 1).

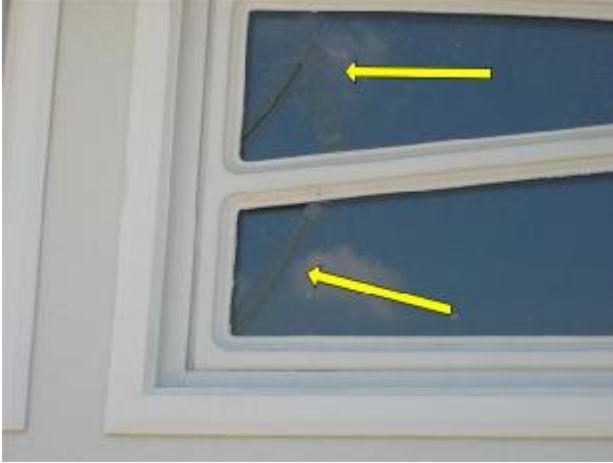
**Garage & Carport # GC1**

20 Cracked window in double overhead door (see photo 1)

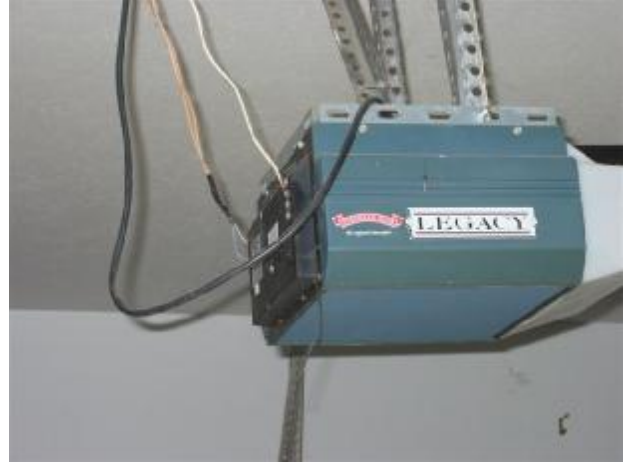
**Garage & Carport # GC2**

Overhead door does not open or close fully unless operator button is held continuously (see photo 2). The stop-reverse switch needs adjusted.

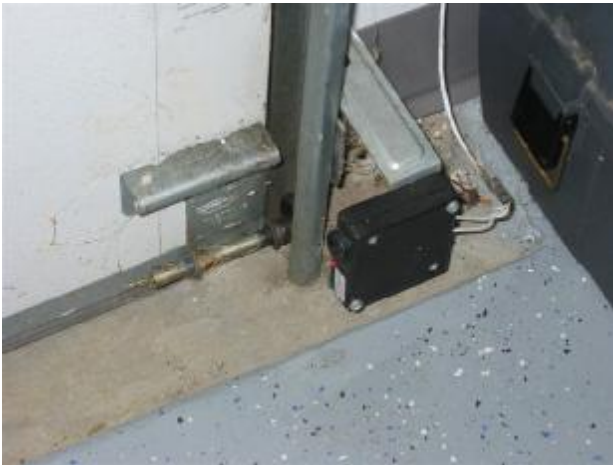
**Garage & Carport # GC3**

Wiring needs to be secured. (see photo 3)

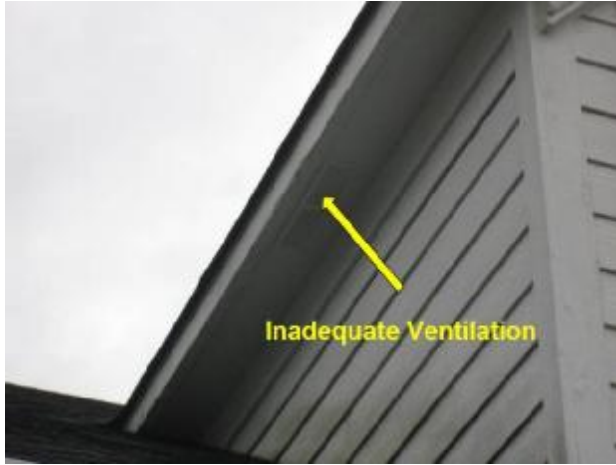
Attic # AT1

- 17 Soffit vents are not cut out adequately and are restricting the flow of air (see photo 1). Reduced or inadequate ventilation can contribute to rapid roof deterioration, mold/mildew (see photos 2 & 3), structural damage and excessive cooling expense in warm weather. Recommend that all vents be evaluated and opened to their maximum design area. Consider adding additional vents and insulation.
